# BEYOND MISINFORMATION

What Science Says About the Destruction of  
World Trade Center Buildings 1, 2, and 7

© 2015 Architects & Engineers for 9/11 Truth, Inc.

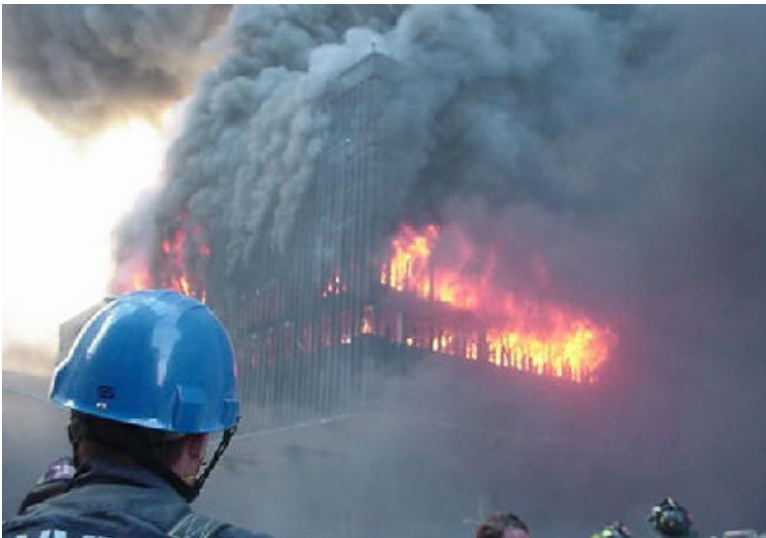
WTC 5 on September 11, 2001.

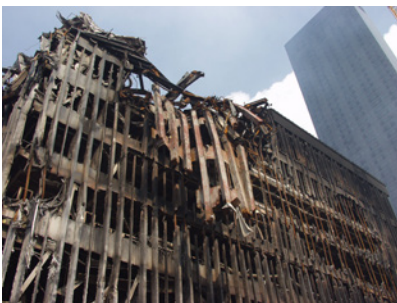
WTC 5 on September 21, 2001.

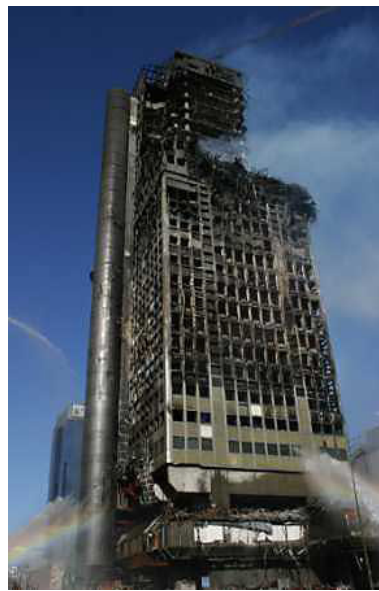
*The Windsor Tower after having burned for almost 24 hours.*

stages over several hours, of floors where the steel support columns and beams had no fire protection. In 2008, the 13-story Delft University Faculty of Architecture Building in the Netherlands, constructed of reinforced concrete, burned for seven hours and experienced a partial collapse of a 13-story section of the building. Yet there remains no documented instance of a steel-framed high-rise building suffering total collapse from fire, and only a small number have experienced partial collapse.

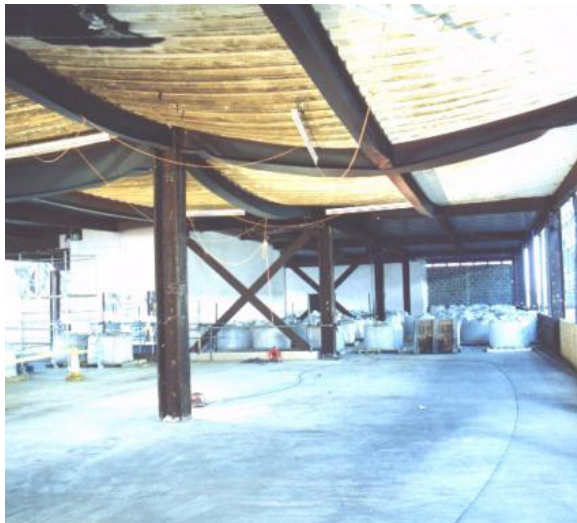
BRE tests in Cardington, United Kingdom.

The NIST survey also noted two major fire test programs conducted at the Building Research Establishment (BRE) Laboratories in Cardington, United Kingdom. The first series of tests, conducted on a representative eight-story composite steel-framed office building, resulted in significant fire damage but did not result in collapse, even with unprotected steel floors. The second series of tests conducted on a seven-story concrete building also did not result in collapse.

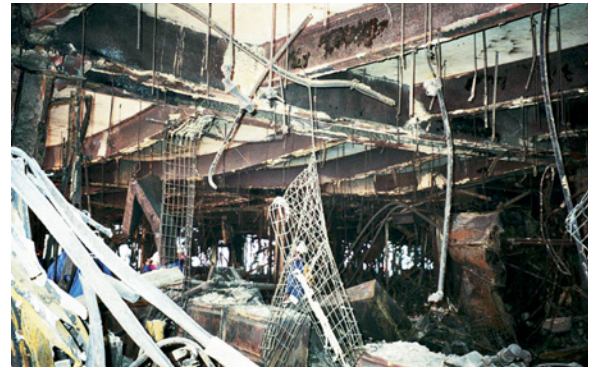
Fire damage in WTC 5 (2002 NIST survey of fires that resulted in total or partial collapse).

- **One New York Plaza** experienced local connection failures resulting in filler beams dropping onto their supporting girders on two floors.
- **Alexis Nihon Plaza** experienced a partial collapse of its 11<sup>th</sup> floor, which was arrested by the floor below it.
- **WTC 5** experienced partial collapses of four floors and two bays.

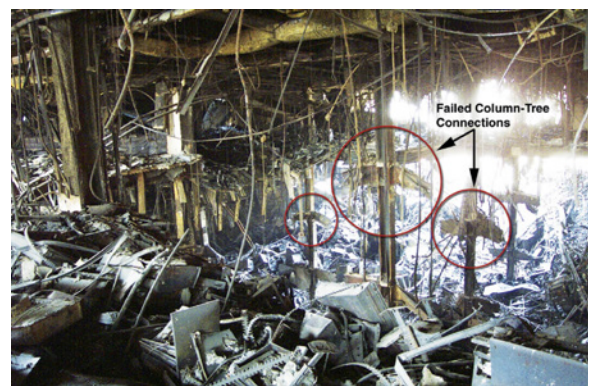
Partial connection and floor failures in WTC 5 (2002 NIST survey of fires that resulted in total or partial collapse).

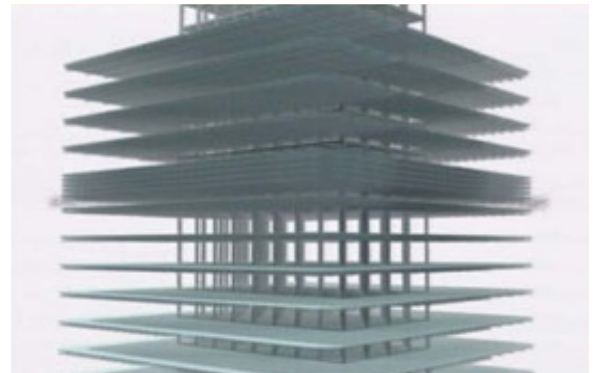
*This PBS NOVA animation attempts to illustrate the “pancake theory.”*

FEMA's scenario for WTC 1 and WTC 2 — which reflected common thinking at that time but was later ruled out by NIST — is what became known as the “pancake theory.” According to this hypothesis, the fires caused the floor trusses to lose their rigidity and sag. As a result of the sagging, the column-to-truss connections failed and the floors collapsed onto the floors below them. This precipitated “an immediate progressive series of floor failures,”

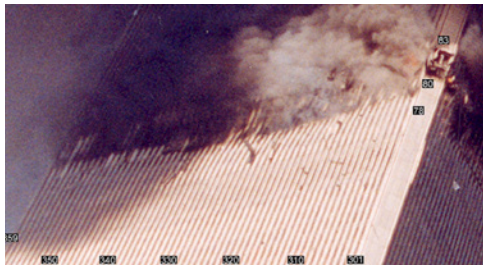
WTC 2 exterior columns bowing inward across the east face between Floors 77 and 83 at 9:58:55 a.m. (NIST NCSTAR 1-6, page 178, Figure 6-21).

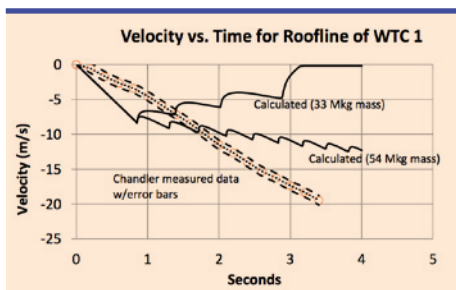
In this graph from Szamboti and Johns' Discussion paper, the observed velocity of the roofline of WTC 1 is compared with the velocity calculated using Bazant and Le's analytical method, but with corrected input values, showing significant decelerations at each floor.<sup>11</sup>

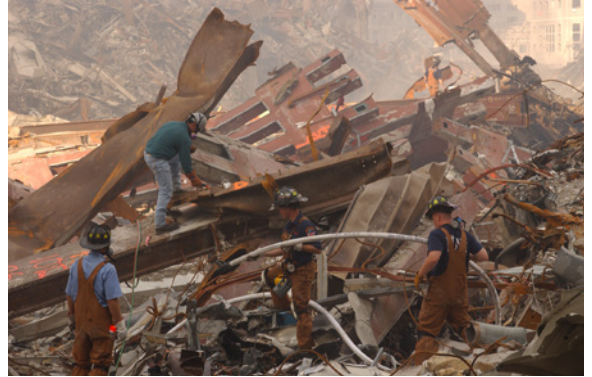
*Debris from the dismembered structures of WTC 1 and WTC 2.*

In addition, the buildings' steel structures were almost entirely dismembered. Aside from some of the exterior walls at the base of each building still standing, virtually all of their steel skeletons were broken up into small pieces, with the core structures separated into individual members and the exterior columns broken up into three-story, prefabricated sections.

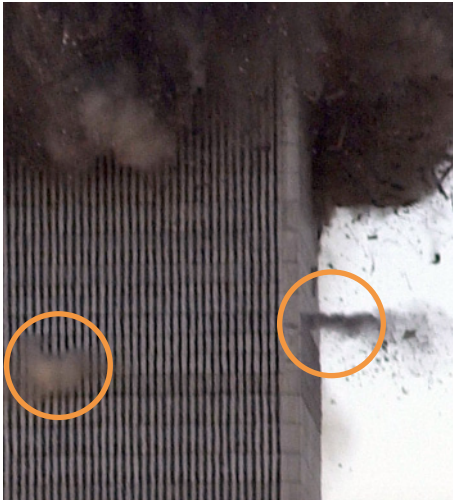
High-velocity bursts of debris, or “squibs,” being ejected from point-like sources in WTC 1 and WTC 2, as many as 20 to 30 stories below the collapse front.

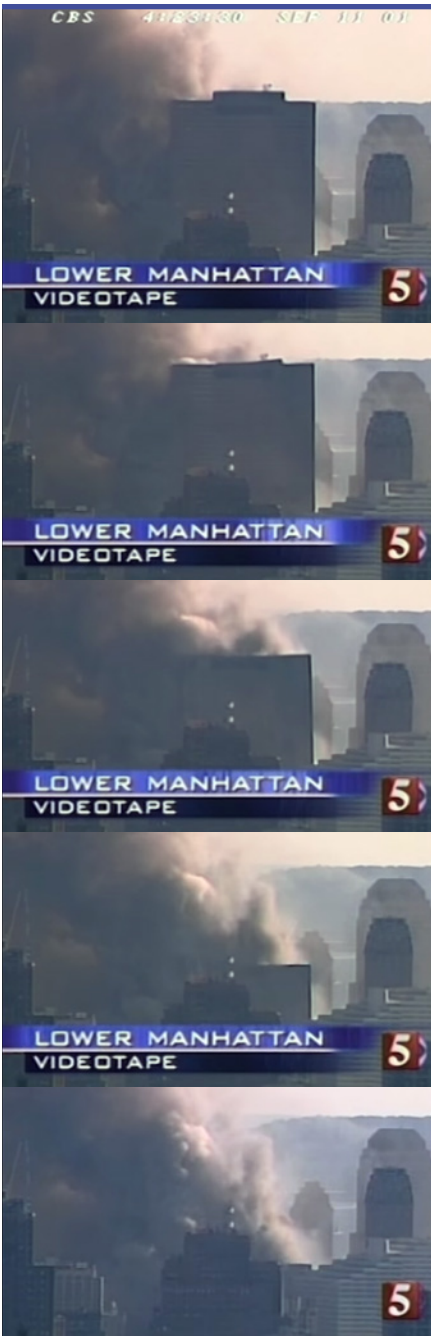
WTC 7 is shown falling symmetrically into its own footprint. It accelerated at free fall for 2.25 seconds of its descent.

Today, NIST acknowledges that WTC 7 fell at a rate of free fall (or the rate of gravity) for a period of approximately 2.25 seconds before it started to

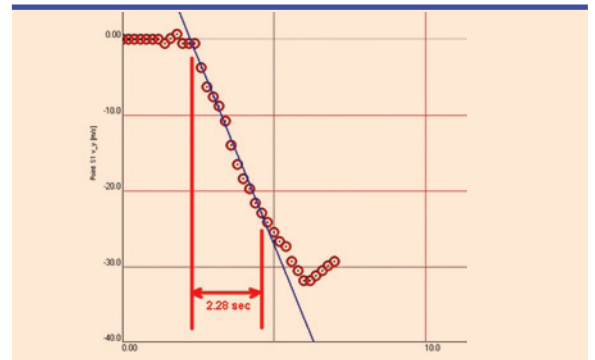
David Chandler's graph from Part 3 of NIST Finally Admits Free Fall plots the velocity of WTC 7's roofline versus time. The slope shows a free-fall rate of acceleration. The sudden change in slope shows the sudden onset of free fall.

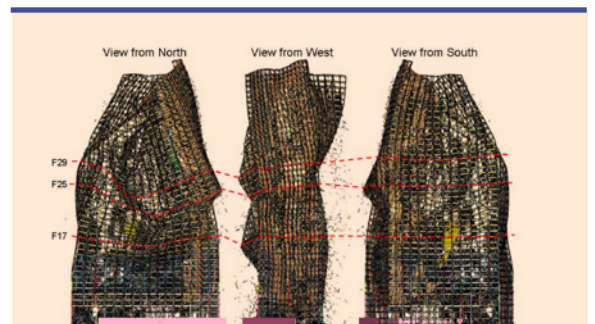
NIST's model of WTC 7's collapse shows large deformations to the exterior of WTC 7 not observed in the videos, while failing to show 2.25 seconds of free fall.

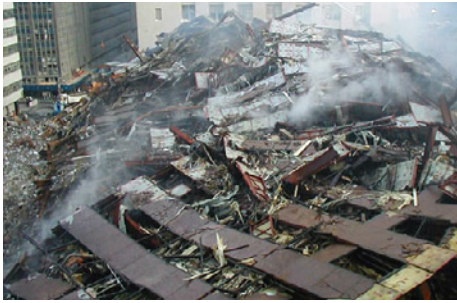
WTC 7's steel structure was dismembered and deposited into a compact debris pile.

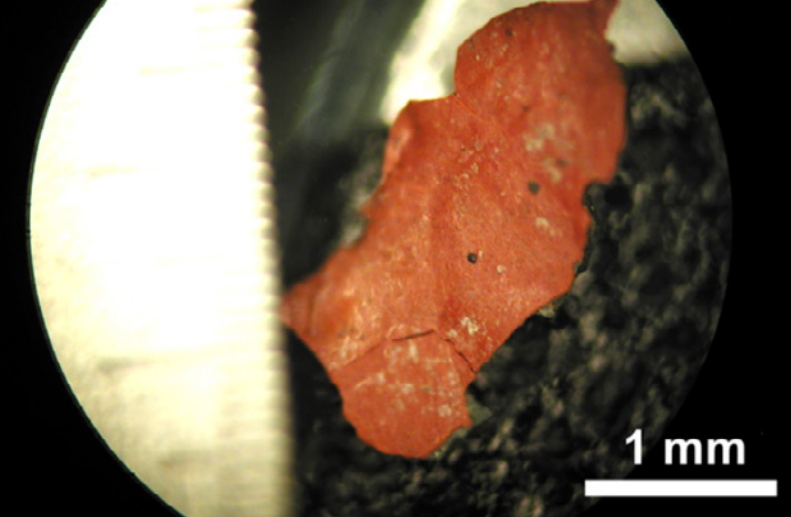
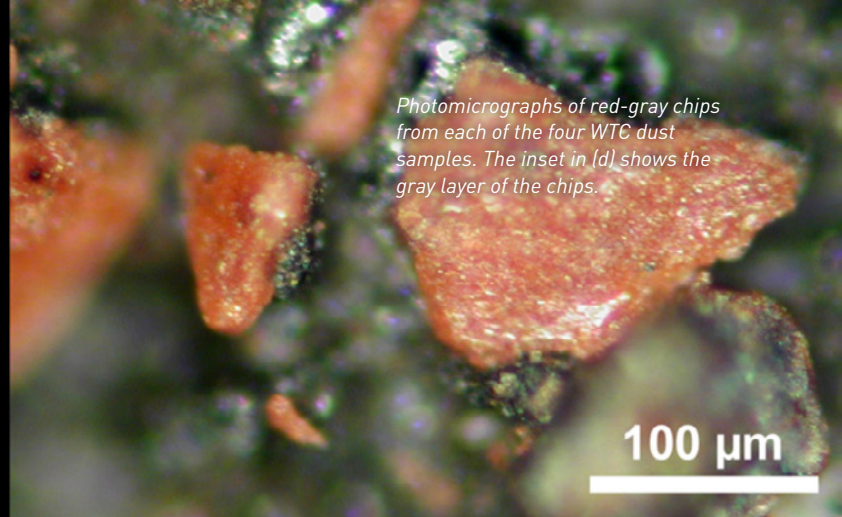
Photomicrographs of red-gray chips from each of the four WTC dust samples. The inset in [d] shows the gray layer of the chips.

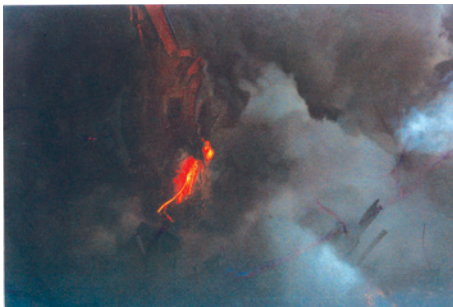
*This photograph, taken by Frank Silecchia on September 27, 2001, shows a piece of metal being dug up that is salmon-to-yellow color, indicating temperatures from 845°C (1,550°F) to 1,040°C (1,900°F).*

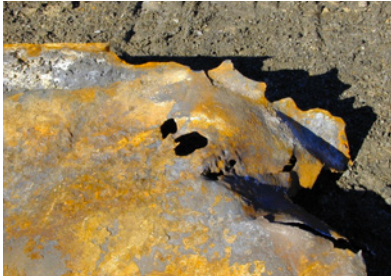
The eroded, sulfidated steel from WTC 7 at the scrapyard before it was cut off and taken for testing.

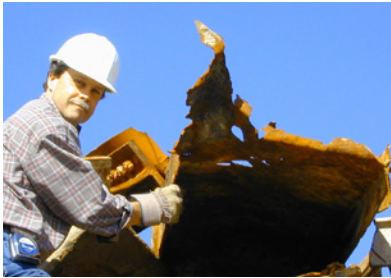
John Gross, who represented NIST on the FEMA Building Performance Study, poses next to the eroded, sulfidated steel. NIST would later claim that no identifiable steel was recovered from WTC 7, and John Gross would deny the existence of molten metal.

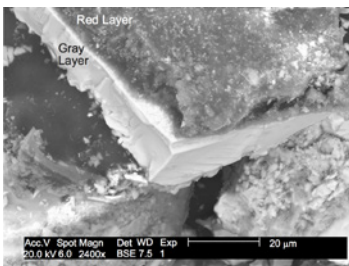
A backscattered electron image of a red-gray chip.

- The chips’ primary ingredients were ultra-fine grain, seen typically “in particles at the scale of tens to hundreds of nanometers.”
- The ultra-fine ingredients were intimately mixed.
- When a flame was applied to them, it resulted in a “high-speed ejection of a hot particle.”

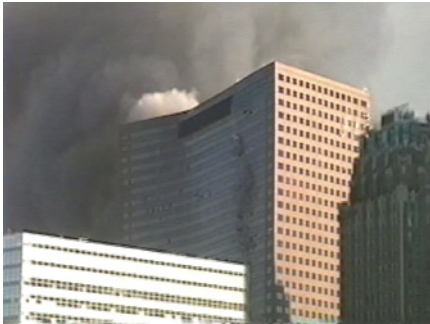
*This video, which surfaced in 2008, clearly shows vertical sequences of explosions and window breakage as WTC 7 begins to collapse. It can be viewed at <http://AE911Truth.org/downloads/video/WTC7-West.mp4>*

Furthermore, the evidence examined in Chapter 4 contradicts NIST’s claim that explosions were not observed by eyewitnesses or captured on video. Indeed, explosions *were* observed by eyewitnesses and captured on video. As one person at the scene recounted, “[I]t looked like there was a shockwave ripping through the building and the windows all busted out.” Video evidence also contradicts NIST’s claim that window breakage did not occur. In particular, a video that surfaced in 2008 clearly shows vertical sequences of explosions and window breakage on the north face of WTC 7 as it began to collapse.<sup>3</sup>

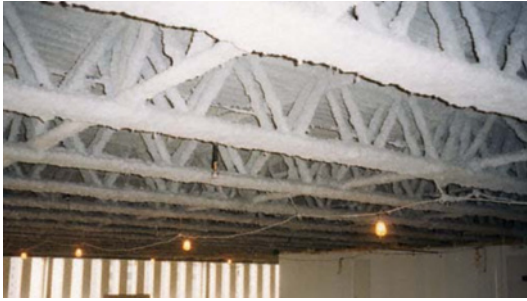
A photograph of WTC trusses with fireproofing.

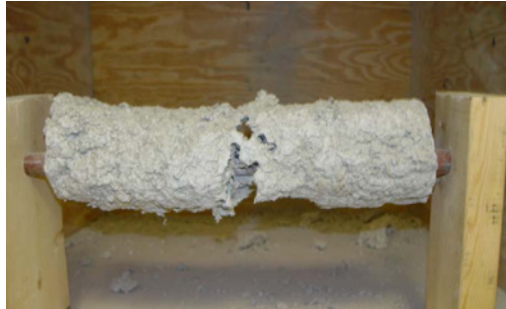
*A photograph from NIST's "Debris Impact Study."*

Because such dislodgement would not have been visible from outside the buildings, the extent of dislodgement had to be estimated based on where NIST's aircraft impact simulations predicted damage to wall partitions or furnishings. At the very end of its investigation, NIST finally performed physical testing "to provide evidence regarding the assumption that...the SFRM used for thermal insulation of structural members was damaged and dislodged." This testing, contained in NIST's "Debris Impact Study," involved shooting 15 rounds from a shotgun at a flat steel plate and a metal bar coated with fireproofing inside a plywood box. Referring to that experiment, Kevin Ryan writes:

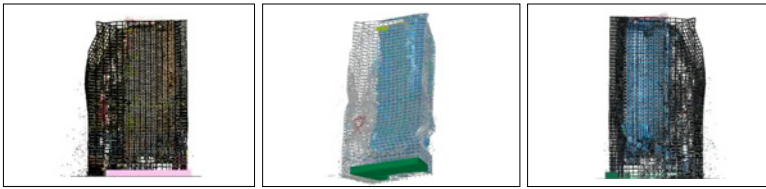
Above: The final frame from three different computer simulations showing WTC 7's collapse from the north, northwest, and south, respectively.

However, when we view the model,<sup>14</sup> we see — besides the fact that it stops after only two seconds,
